How AG Solved Multiple Performance Issues with a Foundry's Problem Permanent Mold

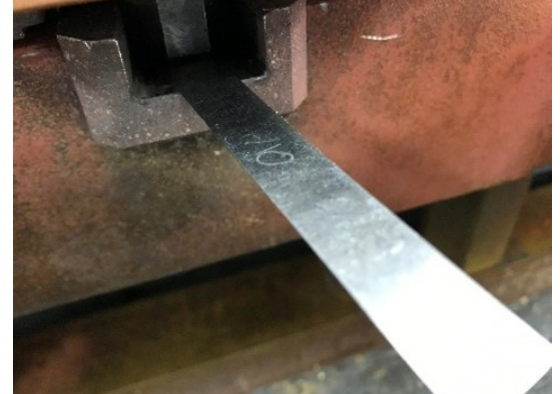
Image #4: Feeler gage being used to assess gap between guide and mold slide.

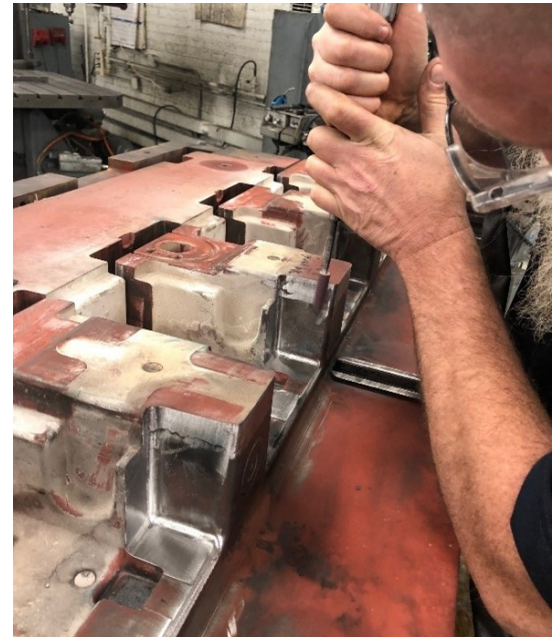
Image #5: Mold being "hot fitted" by AG Journeyman Patternmaker

- The permanent mold was then "hot fitted" at operating temperature. (Image #5) This pointed out areas that had minor clearance issues, due to the normal mold heating and expanding. Clearance was added to strategic locations to maintain the design intent of the permanent mold while at the same time, allowing it to function as required.
